ABANDONED MINE LANDS

BELT - SAND COULEE, MONTANA

VOLUME II A
INVESTIGATION OF ACID DRAINAGE FROM
ABANDONED COAL MINES AND ASSESSMENT
OF POTENTIAL METHODS OF IMPACT ABATEMENT

SAND COULEE AND BELT CREEK
CASCADE COUNTY, MONTANA

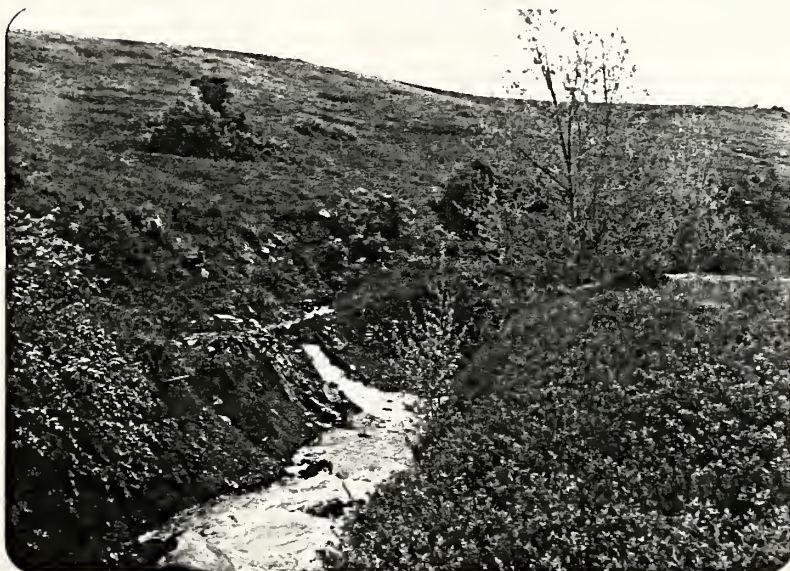
SCM 2 - Mine Discharge Flowing into Sand Coulee
May 21, 1981

For the twelve month period the flow rate from SCM 2 has averaged in excess of 330 gpm. In his 1969 and 1970 study, McArthur (1970) reported the discharge from SCM 2 to reach a high of 150 gpm in October 1969 and a low of 45 gpm in March 1970. The discharge in July 1970 was back up to 135 gpm which is between 200 to 300 gpm lower than the flow measured in July 1981.

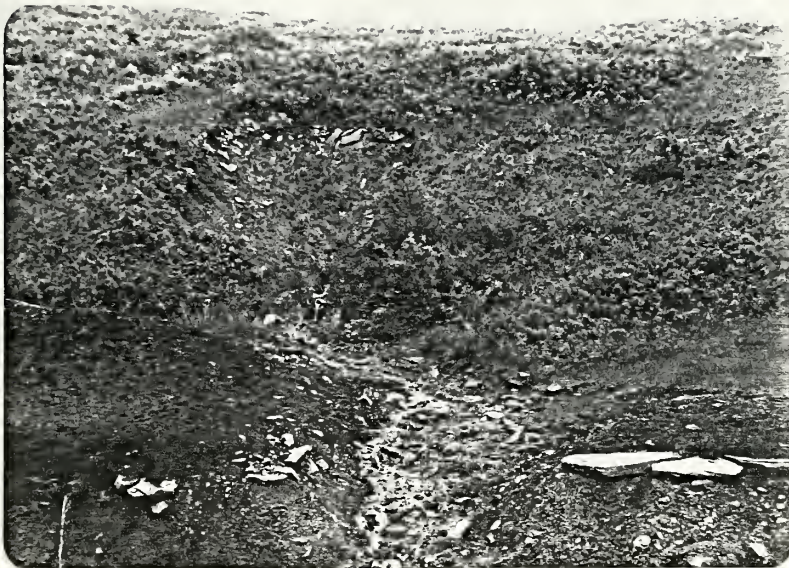
SCM 3 - Mine Portal and Discharge
May 21, 1981

Discharge from SCM 3 was fairly consistent during the past twelve month period (Table 6). Some fluctuations did occur in April 1981 and May 1981 which reflected the spring runoff and precipitation periods (Table 6). The lowest flow was 7 gpm in September 1980 and

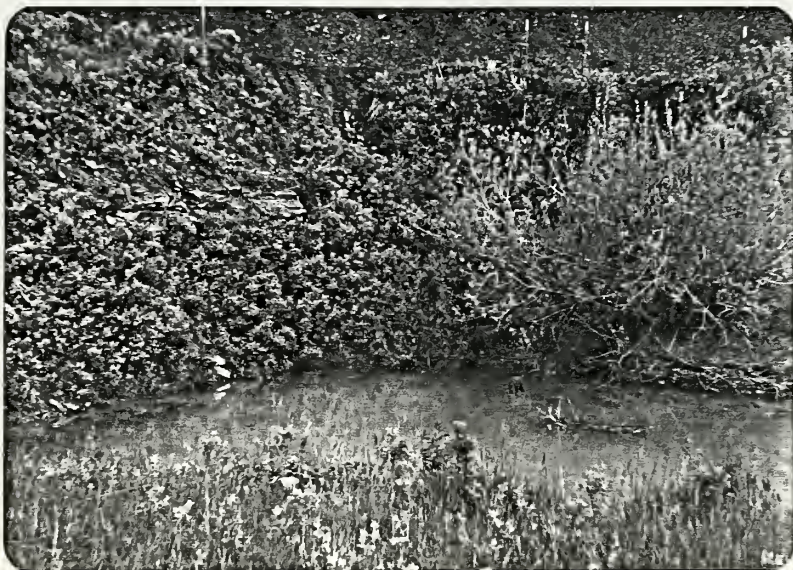
SCM 4 - Mine Portal and Collection Pond

Discharge measurements from Mine SCM 4 (Table 6) show effluent rate from SCM 4 is high in comparison to other mines in the Sand Coulee area. The lowest measurement made was 150 gpm during October 18, 1979, and again September 21, 1980. For most of the 1981 monitoring period (April to May 1981) the discharge from SCM 4 has exceeded 250 gpm. A high of 359 gpm was recorded by the Montana Bureau of Mines and Geology on May 28, 1981.

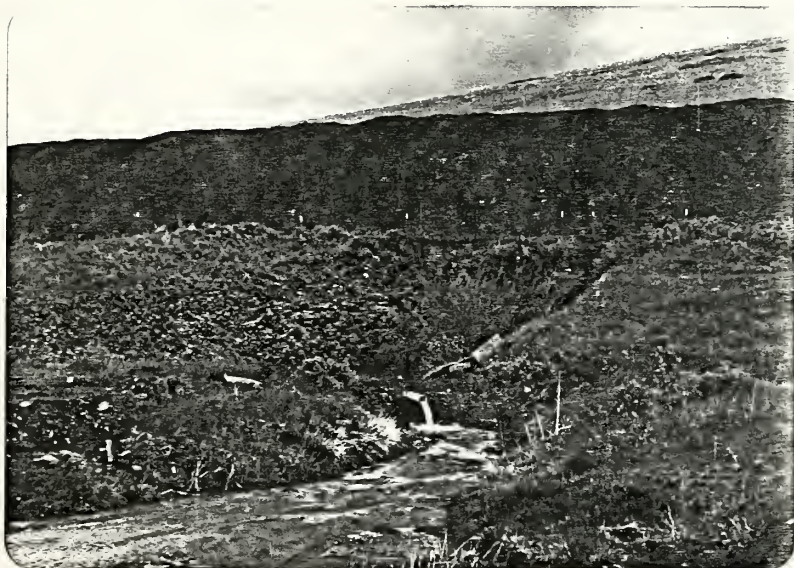
SCM 4 - Pond Overflow and Ditch

Overflow leaves the pool through an 8-inch diameter plastic pipe and enters a 150 foot long iron stained ditch before it enters Five Mile Creek. Five Mile Creek eventually flows into Cottonwood Creek approximately five miles downstream.

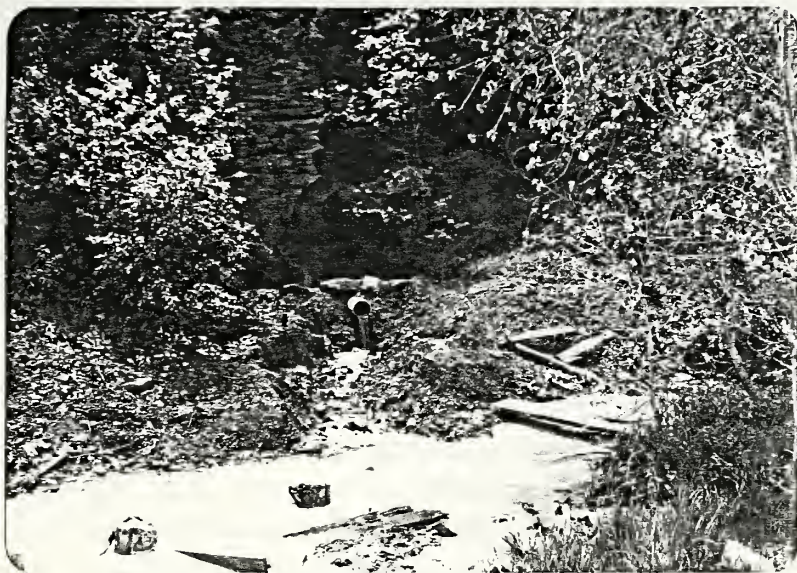
SCM 5 - Mine Portal and Pond Overflow

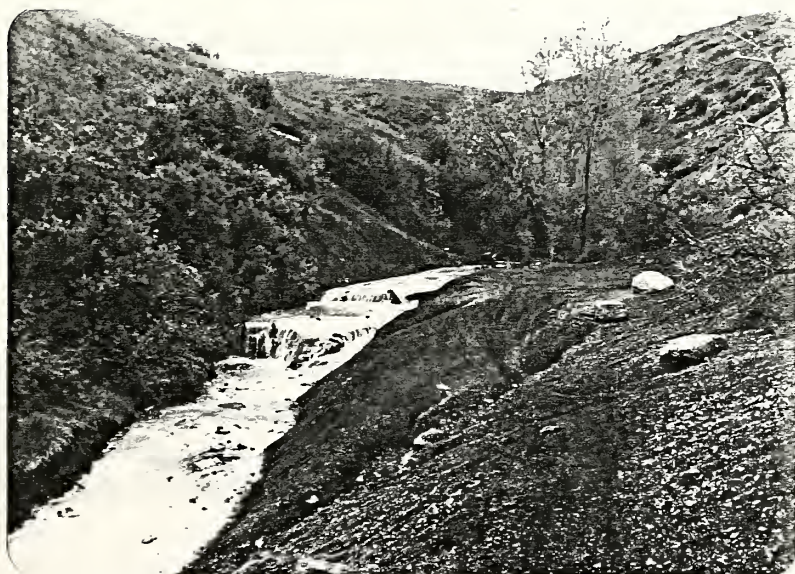
Unnamed Stream Downstream From SCM 5 Discharge

The stream below SCM 5 becomes very turbid and milky colored from the contribution of mine discharge. The stream channel below the water level is covered with a white slimy precipitate (probably aluminum hydroxide). Parts of the stream channel above the water level are reddish orange colored from the iron hydroxide precipitate. The entire stream channel from the mine discharge location to its confluence with Sand Coulee approximately 200 yards downstream exhibits a white chalky color.

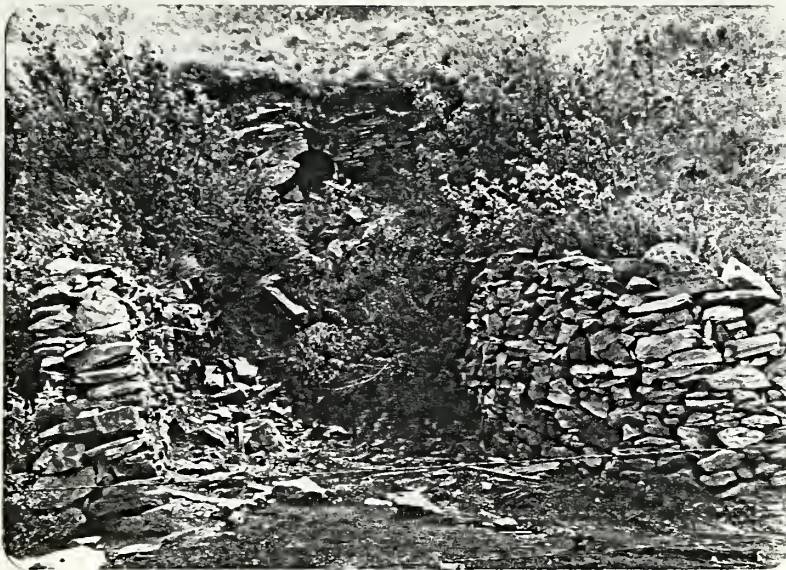
SCM 6 - Mine Portal and Discharge

The discharge from Mine SCM 6 has been very erratic during the past year and has fluctuated from a low of 1.8 gpm on August 14, 1980, to a high of 250 gpm on May 28, 1981, an increase of almost 1400 percent. The large increase in May 1981 is believed largely due to precipitation; however, the increase in April 1981 occurred during a period of little recorded precipitation and after an abnormally dry fall and winter season.

Effluent from SCM 6 has a very low pH which has remained fairly consistent. McArthur recorded the pH at 2.5 during his study which compares to the pH of 2.3 to 2.5 measured during this investigation (Table 8). Specific conductance was reported by McArthur to be 5730 $\mu\text{mhos/cm}$ which is similar to the 5900 $\mu\text{mhos/cm}$ measured in August 1980. Effluent from SCM 6 is very poor in quality with low pH and very high concentrations of total dissolved solids, sulfate, acidity, aluminum, iron and zinc.

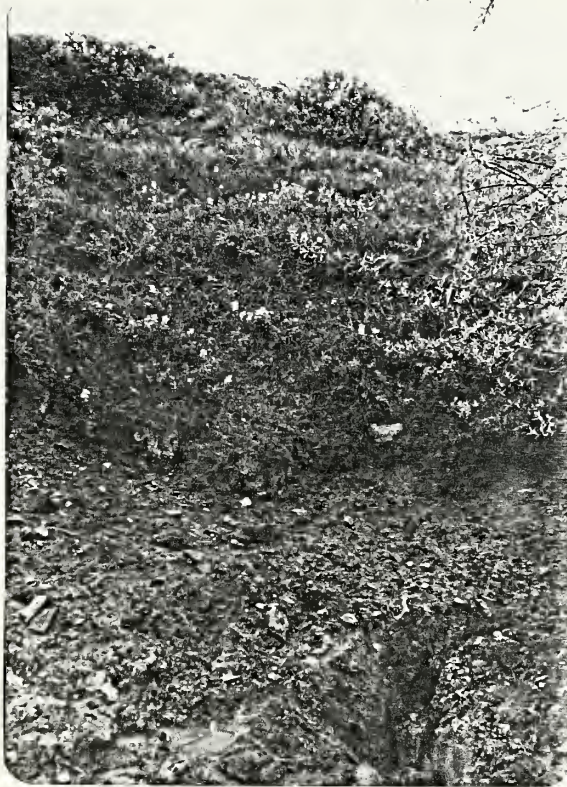
SCM 7 - Mine Portal Site and Discharge

SCM 7 is located about one-half mile northeast of the town of Tracy (19N05E7ABD) and was once part of the old Pierce Mine. The land is owned by Gene Johnson. The adit entrance is completely filled with soil and is covered with vegetation. The only evidence of the adit is the cut in the face of the hillside and some discarded coal and mine wastes downslope from the old adit site. Approximately 20 feet of the coulee below the old entrance is filled with sand and gravel to a depth of between 5 and 10 feet. The mine discharge seeps out from the face

of the fill just above the base. The discharge flows along a small ditch for about 50 feet where it is impounded by a small dam excavated out of the accumulated mine wastes. Overflow leaves the dam and flows down the coulee where it disperses into a wheat field. The high acidity of this water has killed vegetation along its flow path and has ruined approximately five acres of once productive farmland. Discharge onto the wheat field has created a large marsh which is expanding.

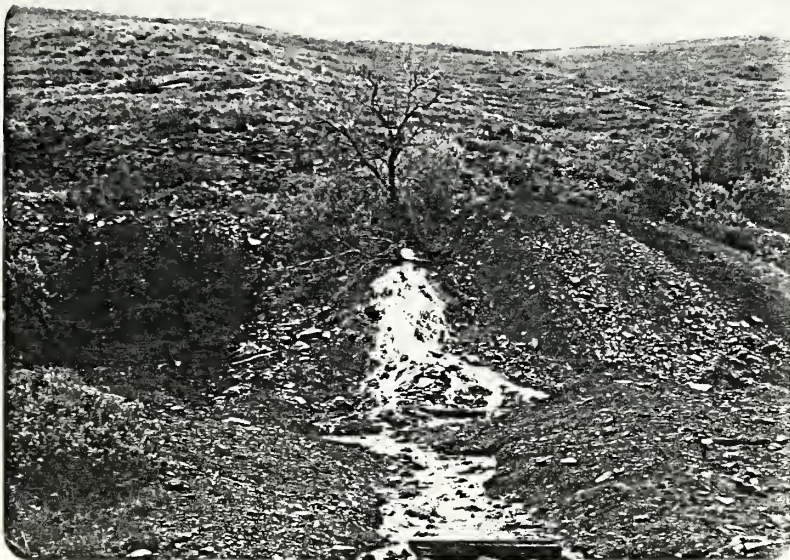
SCM 8 - Mine Discharge

The mine discharge emerges from the mine wastes about 50 feet from the portal where it flows through a 6 inch high by 10 inch wide wooden trough. Discharge from the trough flows down the waste pile into a ditch and eventually enters a stream in the coulee. This stream is partially fed from springs located at the upper end of the coulee but streamflow contains a significant quantity of mine discharge. The stream flows northward along the foot of a hill for about 300 yards to a grain field and is dispersed.

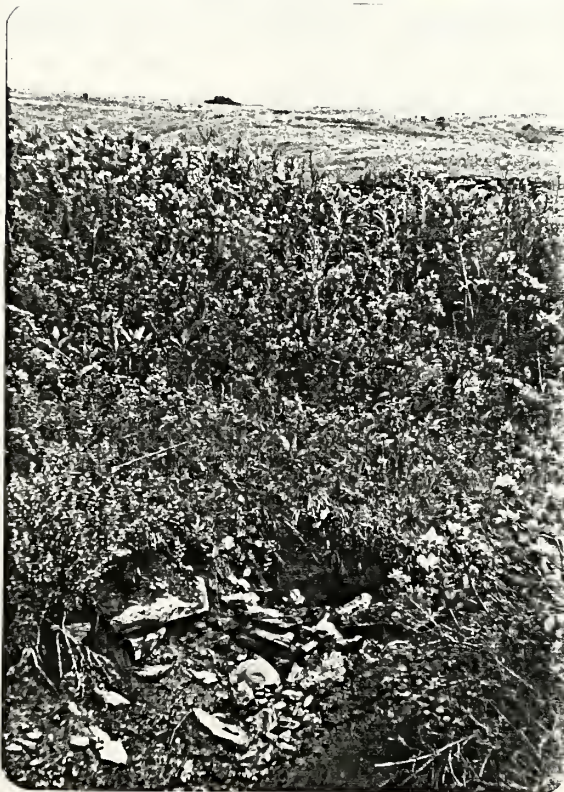
SCM 9 - Mine Discharge

Discharge from Mine SCM 9 has been highly variable and has ranged from a low of 8 gpm recorded on October 18, 1979, to a high of 166 gpm on June 13, 1981. Table 6 lists the discharge measurements for SCM 9

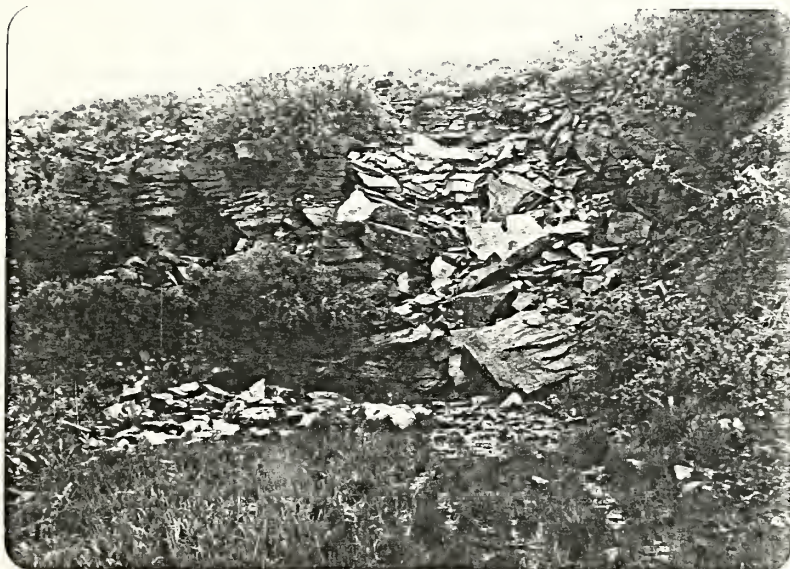
SCM 15 - Mine Portal With Small Iron
Stain at Pool at Base of Rock Fill

SCM 15 is located about one mile northeast of Tracy approximately 1500 feet northeast of SCM 7 (19N05E7AAAA). This mine is on land owned by Gene Johnson and is believed to be part of the old Carbon Mine. The mine entrance has completely collapsed and is covered with rock from the overlying sandstone bed. There is apparently another portal just adjacent to the discharging one which has a timbered entry and is still partially open. Discharge from the one mine emanates from the base of the pile of collapsed sandstone and collects into a small pond. The overflow then continues down-slope along a manmade ditch from about 200 feet, then flows along another ditch adjacent to a grain field and eventually disappears into the subsurface. Mine wastes from the SCM 15 mine are considerable and extend laterally from 60 feet to over 100 feet beyond the portals. The piles reach a depth of over 12 feet.

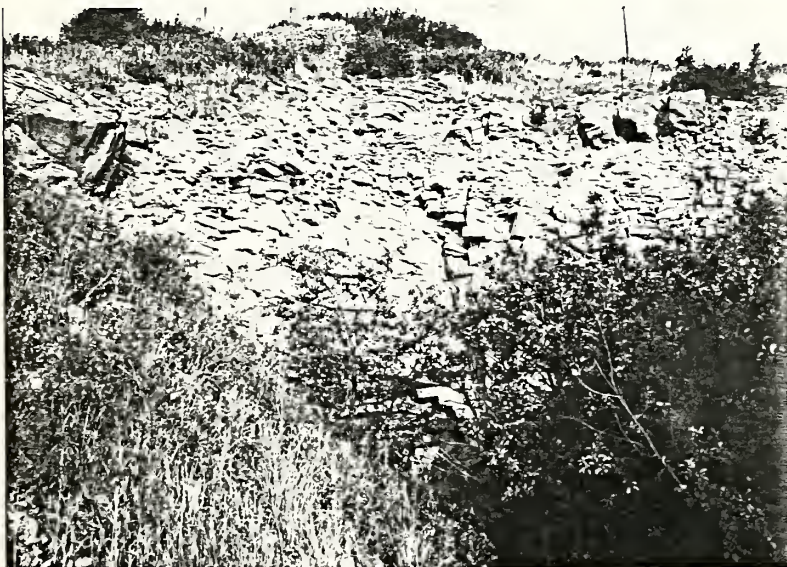
BM 1 - Mine Portal

Flow from BM 1 has ranged from 80 to 166 gpm (Table 16) and the effects of heavy precipitation in May 1981 had little affect on the mine discharge.

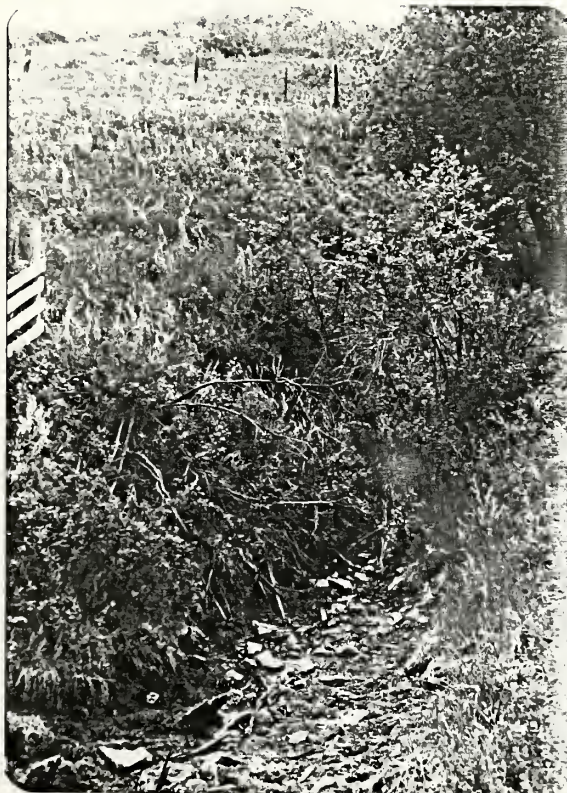
BM 2 - Mine Portal

Flow from BM 2 has varied widely (5 to 71 gpm, Table 16) reflecting the influence of precipitation in May and June 1981. Flows rapidly increased, peaked, then rapidly declined showing the good hydraulic contact between the mine and the overlying Kootenai Formation.

Quality of effluent from BM 2 (Table 17) is very poor. Very low pH, high concentrations of acidity, sulfate and dissolved solids and metals make this water much poorer in quality than BM 1.

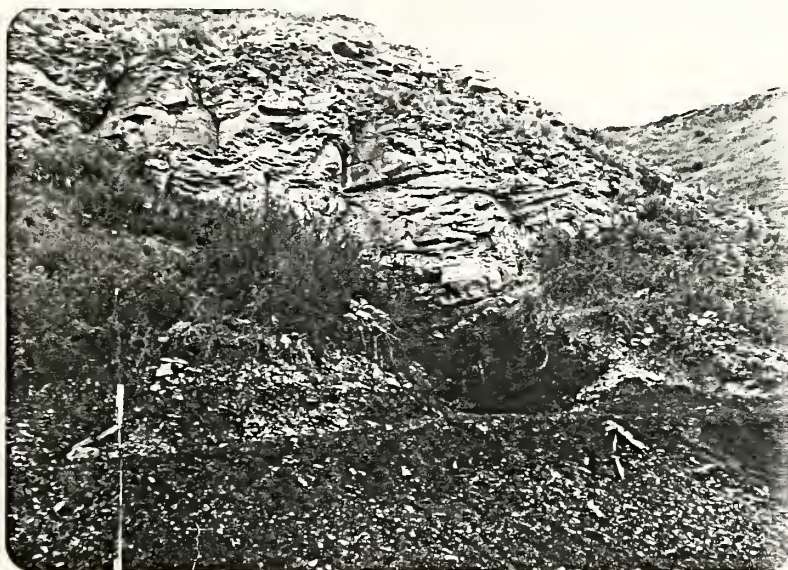
BM 3 - Mine Portal

Quality of acid mine drainage from BM 3 is very poor. The AMD characteristics of low pH, and high concentrations of acidity, sulfate, dissolved solids and metals are present in this water (Table 17).
